RE: Review of Downstream Conditions  
Drainage District No. 35  
Project No.: 24X.134908.000

CERRO GORDO COUNTY, IOWA  
 DD 35 MAIN TILE & DITCH REPAIR  
 PLAN & PROFILE

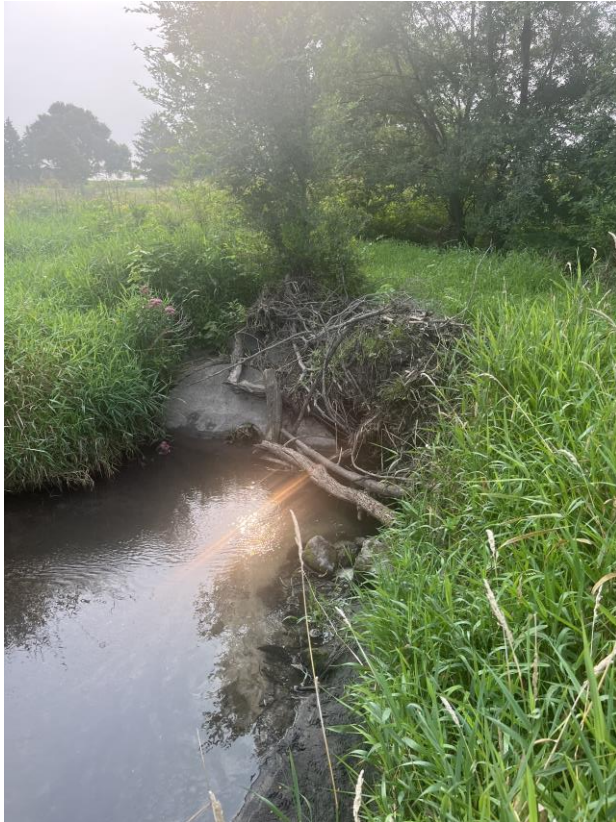
*Figure 1 Upstream Side of Crossing*

From the included photos, water on the upstream portion of the crossing is higher than water on the downstream side, and debris is collecting on the upstream face of the crossing. This would imply that water is being impeded by this crossing.

This report has confirmed that steps should be taken to remove or avoid the downstream crossing culvert that is acting as a District obstruction. This could be accomplished in one of three ways. First, the District could follow the right-of-way proceedings, outlined in Iowa Code Chapter 468, including the appointment of appraisers, tasked with submitting an appraisers' report and obtain right-of-way downstream of the District Outlet (potentially to the downstream bridge on 250<sup>th</sup> Street). After obtaining the right-of-way, the district could then require that the landowner remove that obstruction at the landowner expense. Second, the District could come to an agreement with the downstream crossing owner, for the District's removal of the obstruction. Lastly, the District could reroute the Main Tile approximately 100 feet to the south to outlet downstream of the existing crossing pipe. Regardless of the decision to manage the downstream crossing culvert, the existing Main Tile damage will need to be repaired. Attached to this report is an opinion of probable cost that outlines the potential costs of each option as well as including the repair portion of the main tile.

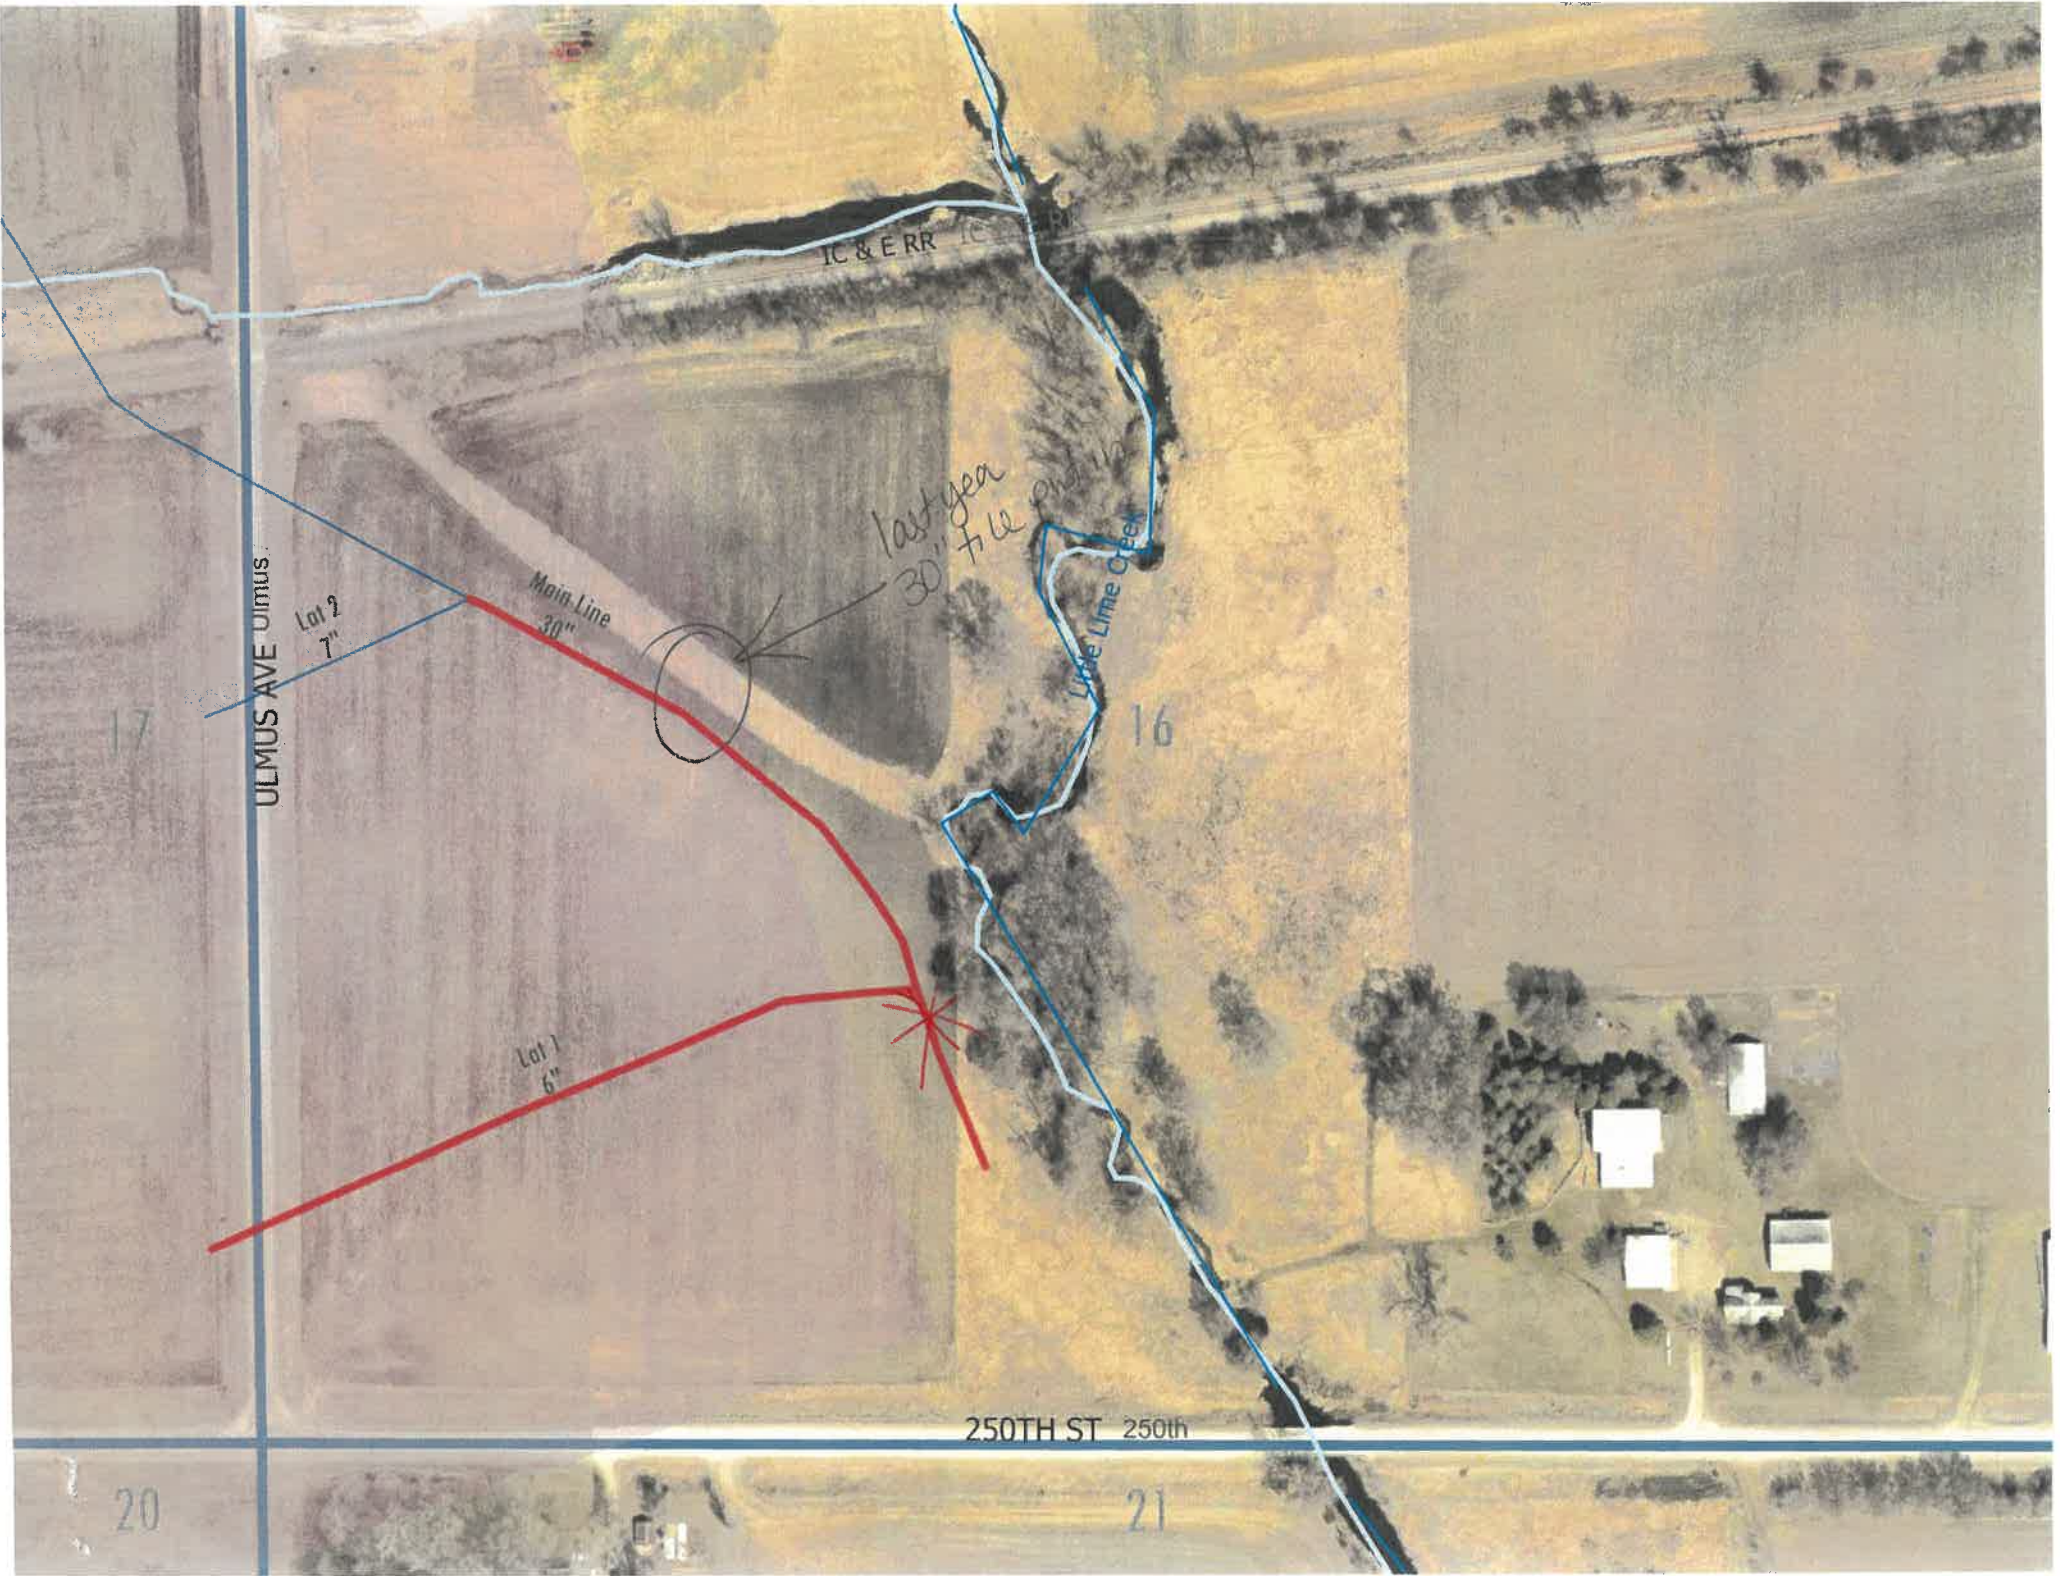
1) ~~X~~ Johnson Tiling put  
30" tile last year.  
It already broke.

→ The 30 inch dumping into this creek  
already

and additional private  
north of 18 got ~~that~~  
tied into this Main  
line → so more water

2) if we could remove  
culvert ≈ dam, it  
would improve drainage  
for DD35 greatly!

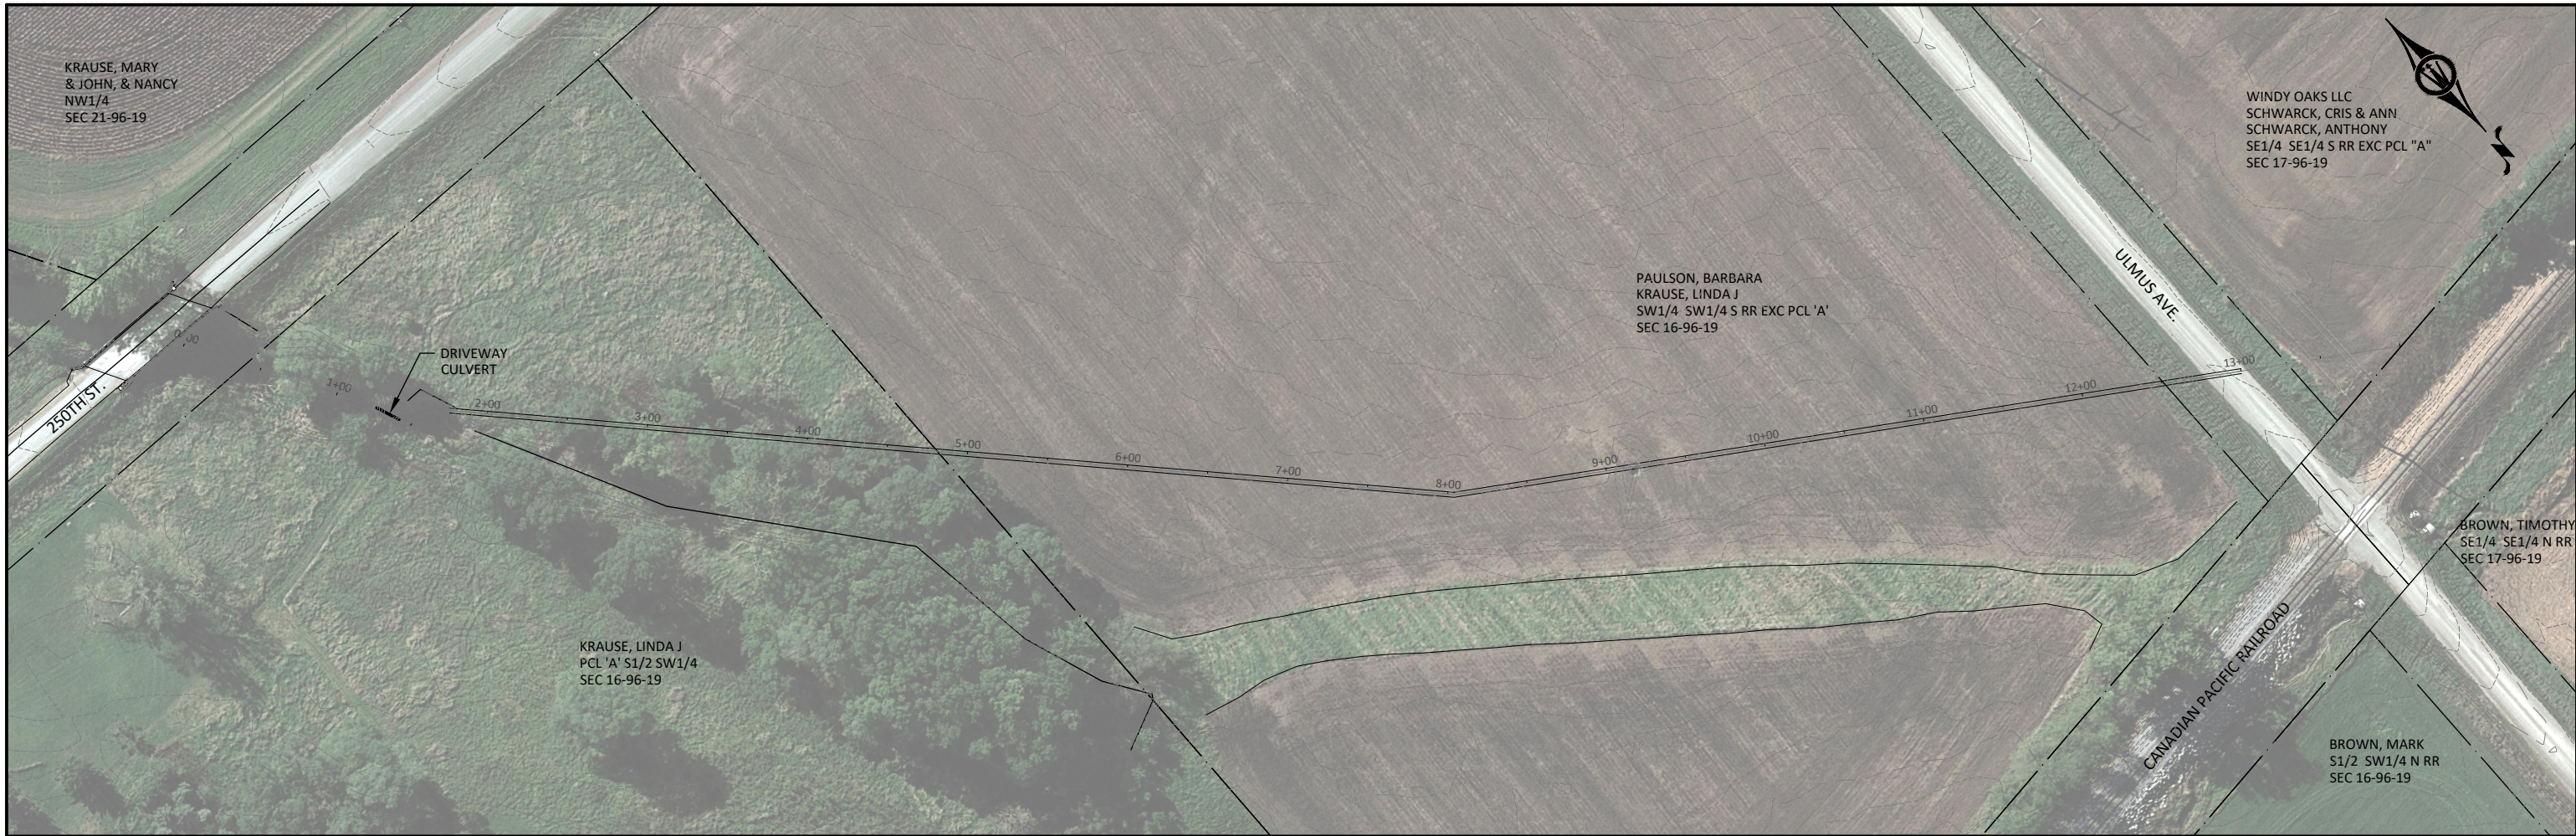
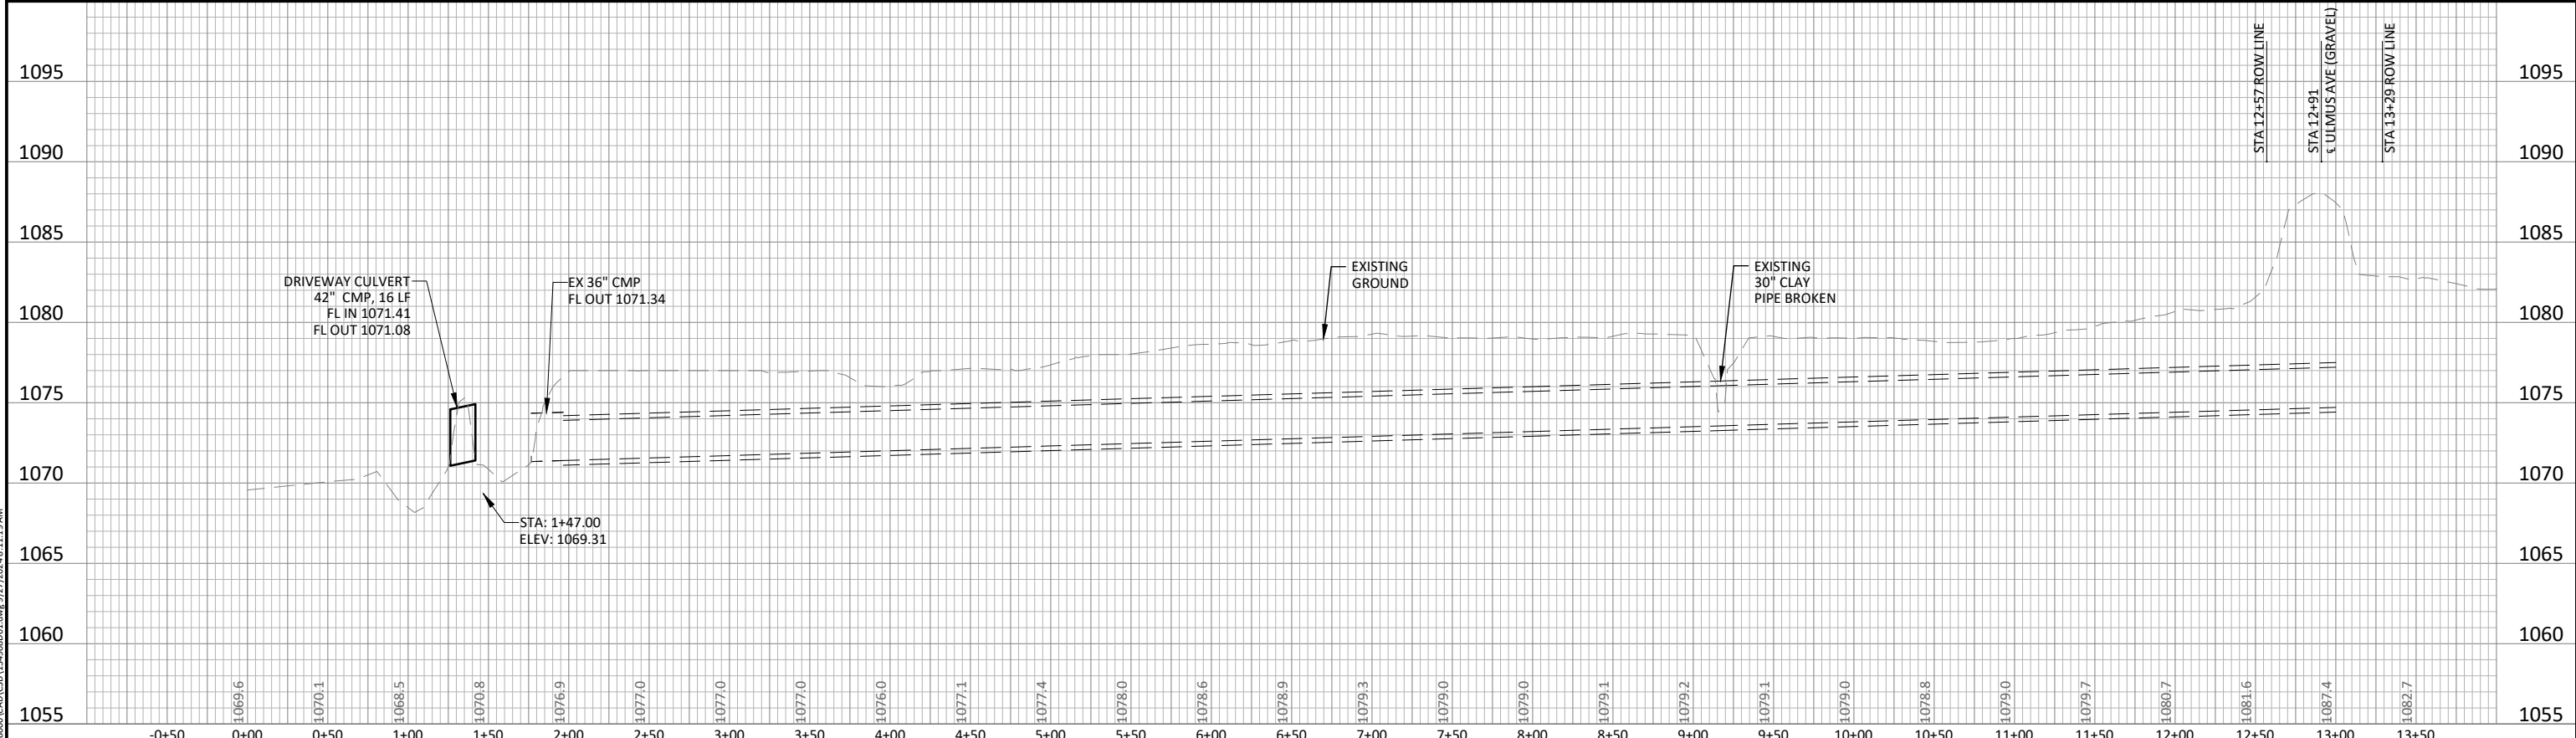
SHEET  
**D.01**

From this field data acquisition, a preliminary set of plans were developed to outline these findings. In summary, the findings from the field were: The outlet of the Main Tile is a 30-inch pipe, at an elevation of 1,071.34 feet. The downstream culvert crossing of the open channel is a 42-inch corrugated metal pipe with an upstream invert elevation of 1,071.41 feet. This means that the outlet of the District Main is below the elevation as the downstream culvert. This translates to a negative ditch grade, while the likely intended open channel grade, based on survived cross-sections is 0.10%. Additionally, though the Drainage District has an assessed area of 2,597.50 acres, the total watershed size that flows through that crossing pipe was found to be approximately 4,350.00 acres. This means that the flow of drainage district waters is not the only responsibility of this crossing culvert. Attached to this report is a set of plans, marked as preliminary, that display these findings geometrically.
