September 30, 2024

RE: Review of Downstream Conditions Drainage District No. 35 Project No.: 24X.134908.000

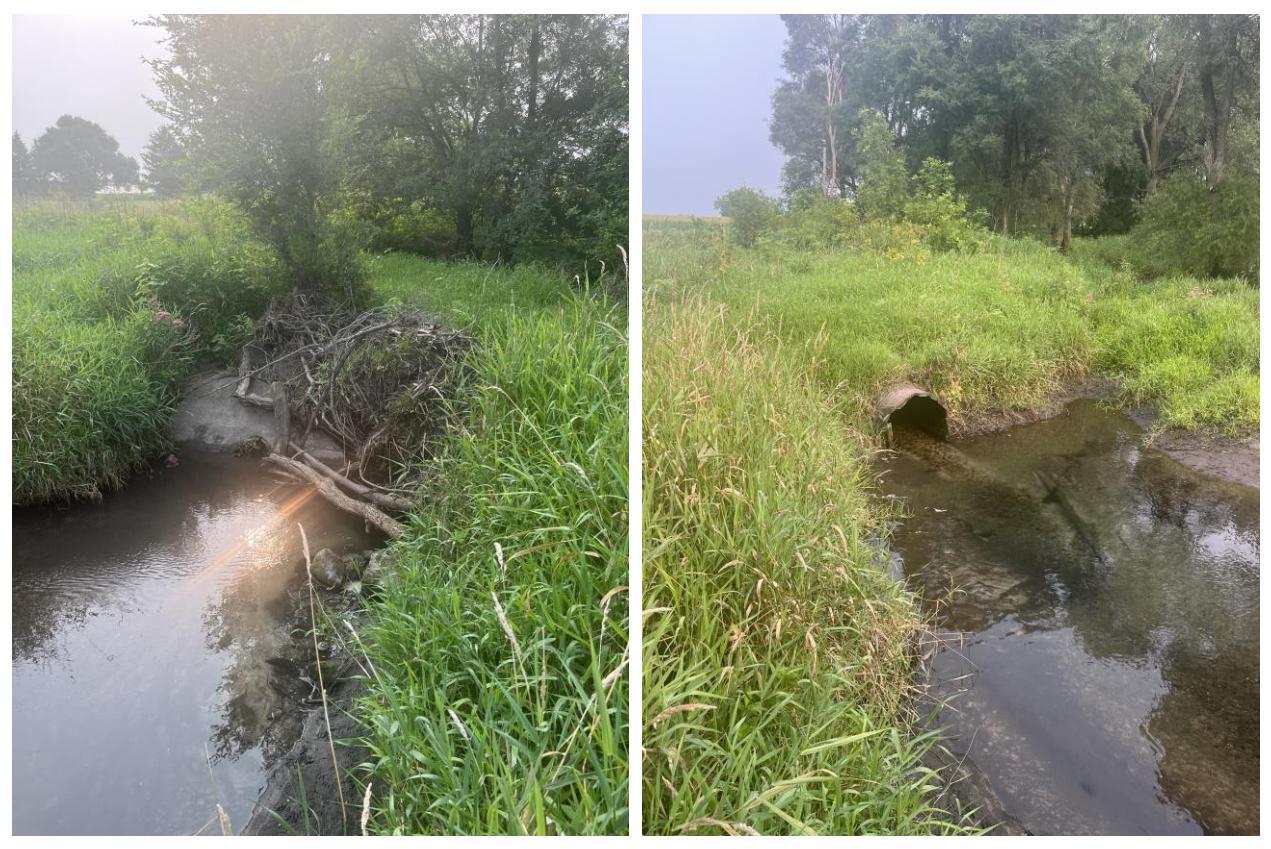
Figure 1 Upstream Side of Crossing

Figure 2 Downstream Side of Crossing

From the included photos, water on the upstream portion of the crossing is higher than water on the downstream side, and debris is collecting on the upstream face of the crossing. This would imply that water is being impeded by this crossing.

From the Iowa Drainage Guide, utilizing the drainage curves for grain crops in Iowa, the open channel design flow quantity for that size of watershed is 207 cubic feet per second of water. This volume of water was modeled against the current culvert conditions. The existing culvert capacity was found to be inadequate based on that evaluation, and it is estimated that from that volume of water the culvert would be overtopped. This means that under any normal design criteria events (2-year, 48-hour storms) or larger storm, the drainage district outlet becomes submerged, which creates a forced outlet. This forced outlet condition increases the internal pressure on the upstream portions of the tile system, namely the

immediate upstream segments of tile. This increased pressure increases the likelihood of damage, and complete failures of tile segments, similar to those that the District is already experiencing. For comparison, the downstream road crossing, on 250<sup>th</sup> Street, is a bridge structure. This is no doubt a bridge, as it has been sized for the large amounts of water that can be generated within this watershed.

This report has confirmed that steps should be taken to remove or avoid the downstream crossing culvert that is acting as a District obstruction. This could be accomplished in one of three ways. First, the District could follow the right-of-way proceedings, outlined in Iowa Code Chapter 468, including the appointment of appraisers, tasked with submitting an appraisers' report and obtain right-of-way downstream of the District Outlet (potentially to the downstream bridge on 250<sup>th</sup> Street). After obtaining the right-of-way, the district could then require that the landowner remove that obstruction at the landowner expense. Second, the District could come to an agreement with the downstream crossing owner, for the District's removal of the obstruction. Lastly, the District could reroute the Main Tile approximately 100 feet to the south to outlet downstream of the existing crossing pipe. Regardless of the decision to manage the downstream crossing culvert, the existing Main Tile damage will need to be repaired. Attached to this report is an opinion of probable cost that outlines the potential costs of each option as well as including the repair portion of the main tile.
