September 30, 2024

RE: Review of Downstream Conditions Drainage District No. 35 Project No.: 24X.134908.000

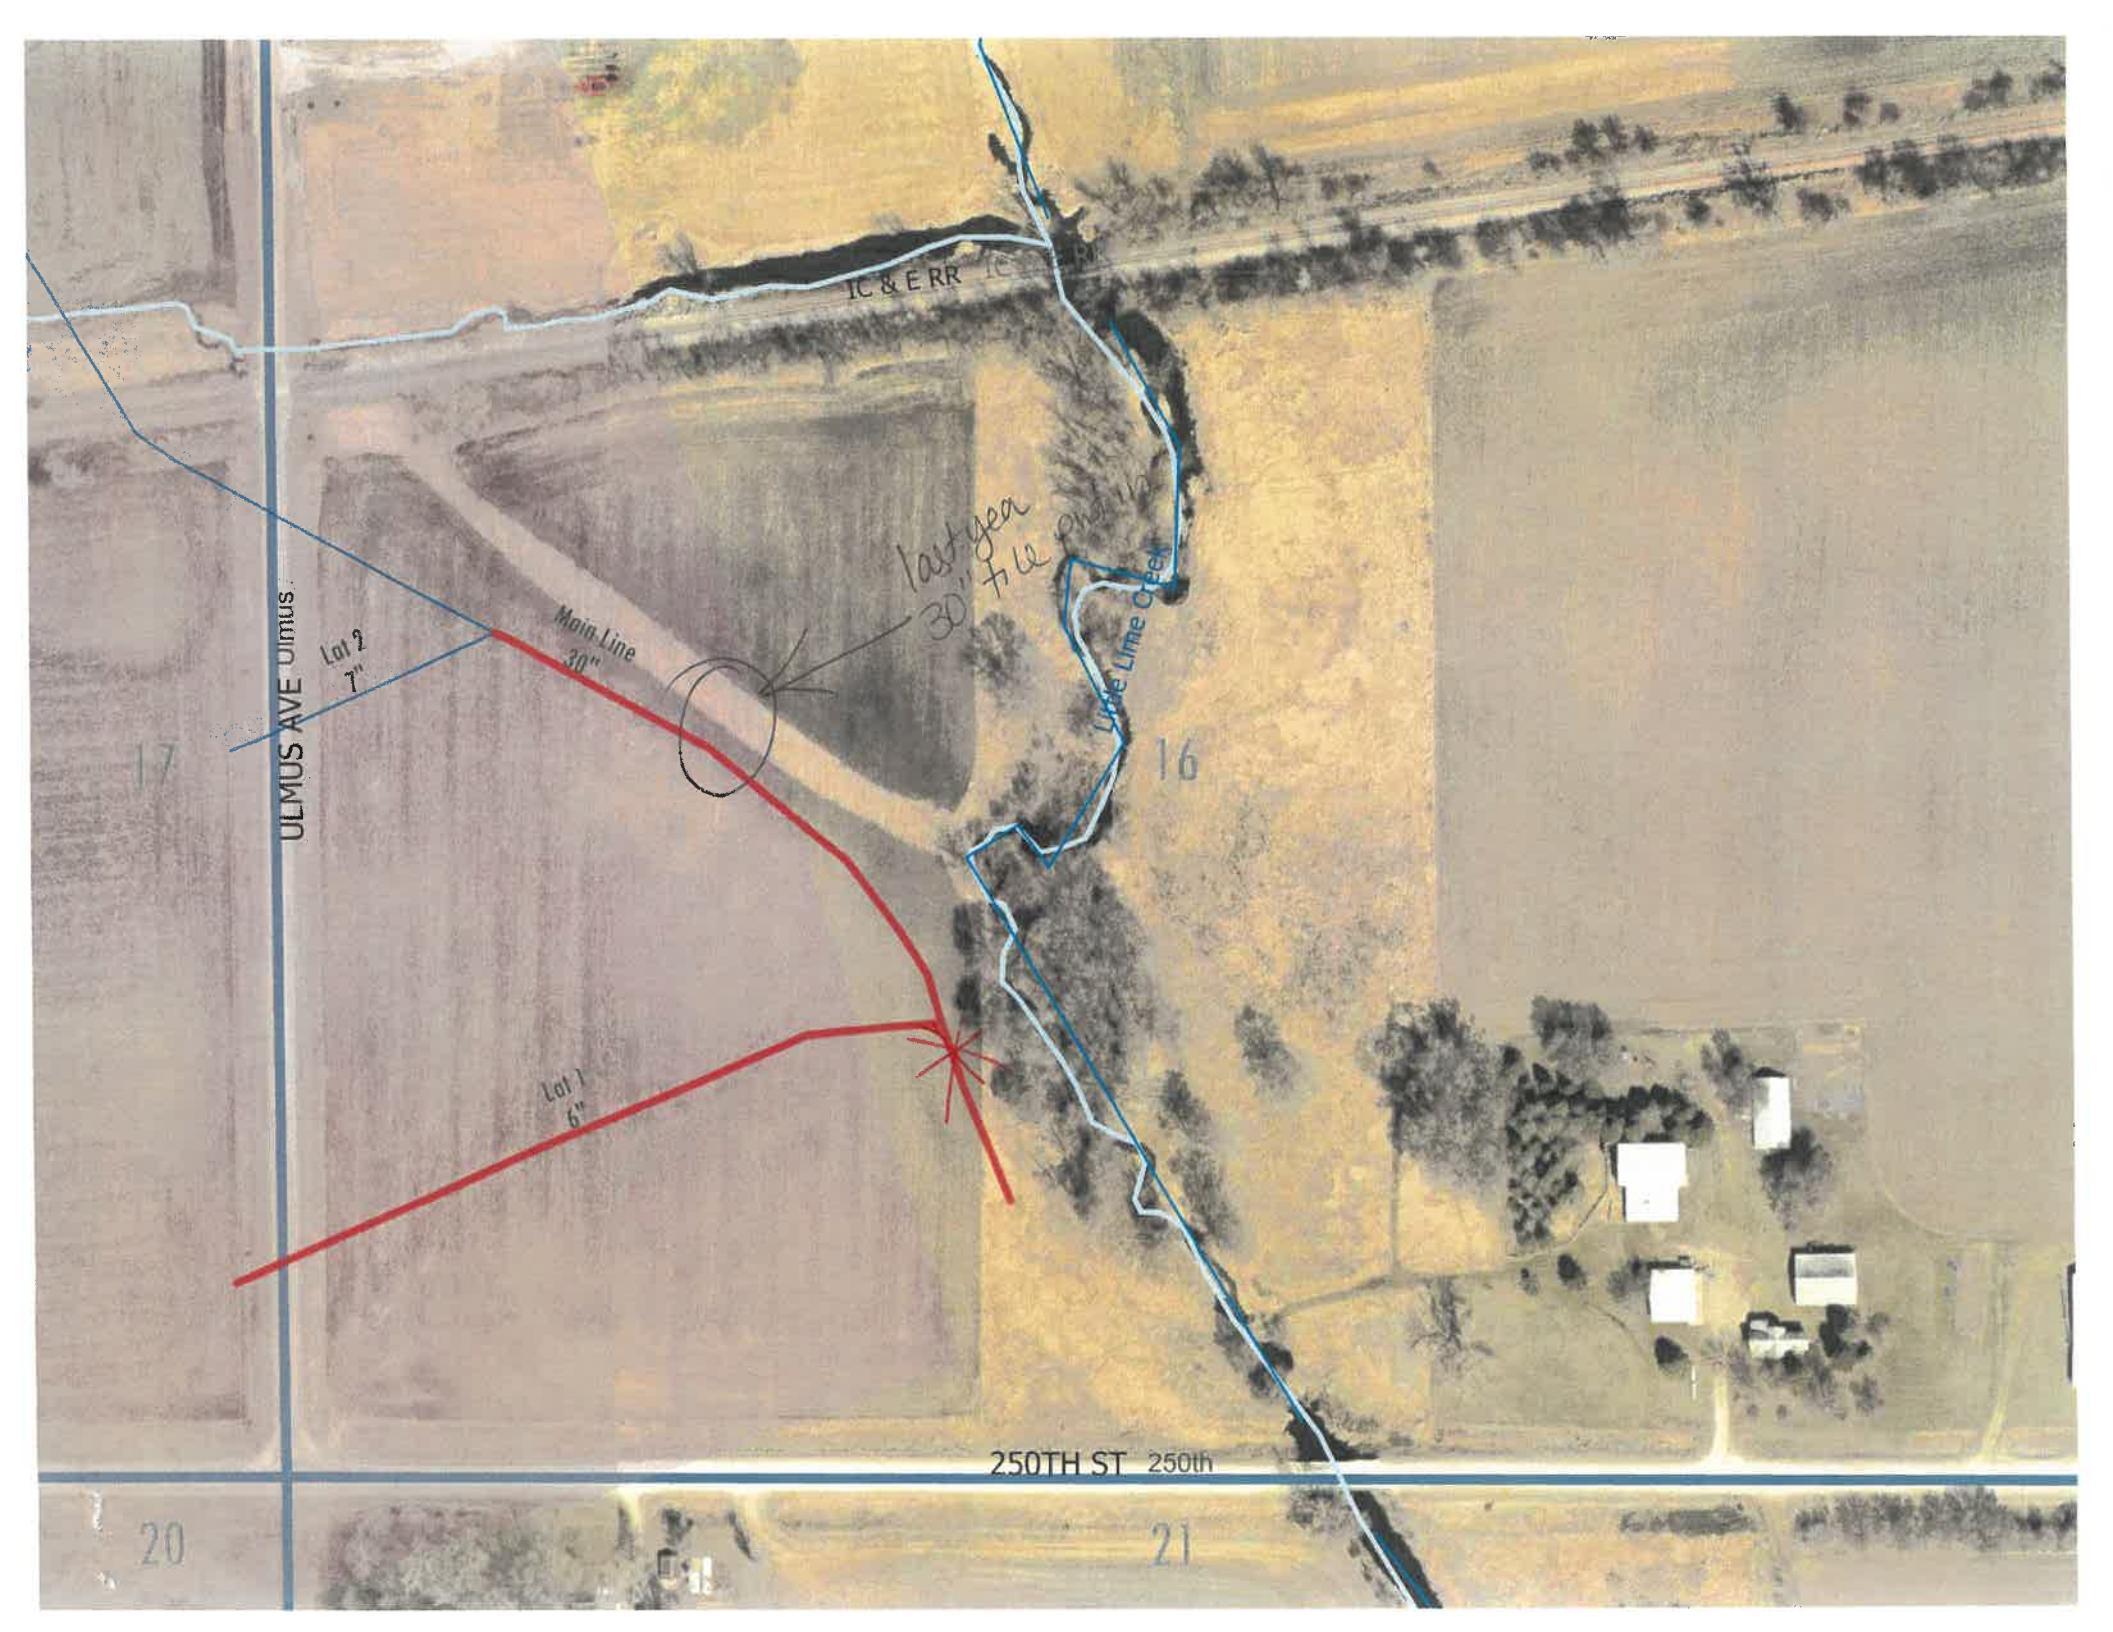
) X 30" tile last year. ) It already broke. -> The 30 is already

-> The 30 inch dumping into this creek

and additional private north of 18 got that tied into this Main Line > 80 Mars water

if we could remove ~ little lime Gree Culvert 3 dam, it would improve drainage fin DD 35 greatly! But this involves

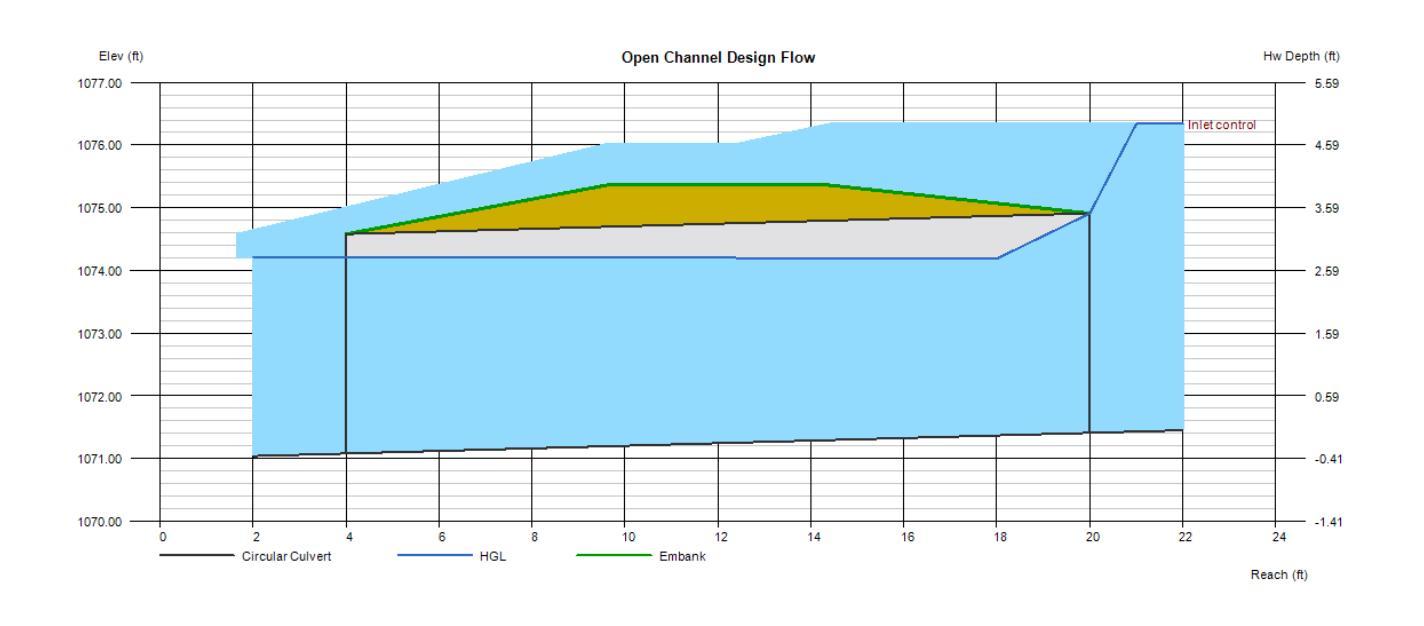
# **Culvert Report**

From the Iowa Drainage Guide, utilizing the drainage curves for grain crops in Iowa, the open channel design flow quantity for that size of watershed is 207 cubic feet per second of water. This volume of water was modeled against the current culvert conditions. The existing culvert capacity was found to be inadequate based on that evaluation, and it is estimated that from that volume of water the culvert would be overtopped. This means that under any normal design criteria events (2-year, 48-hour storms) or larger storm, the drainage district outlet becomes submerged, which creates a forced outlet. This forced outlet condition increases the internal pressure on the upstream portions of the tile system, namely the

immediate upstream segments of tile. This increased pressure increases the likelihood of damage, and complete failures of tile segments, similar to those that the District is already experiencing. For comparison, the downstream road crossing, on 250<sup>th</sup> Street, is a bridge structure. This is no doubt a bridge, as it has been sized for the large amounts of water that can be generated within this watershed.

Invert Elev Dn (ft)	= 1071.08	Calculations	
Pipe Length (ft)	= 16.00	Qmin (cfs)	= 207.00
Slope (%)	= 2.06	Qmax (cfs)	= 207.00
Invert Elev Up (ft)	= 1071.41	Tailwater Élev (ft)	= (dc+D)/2
Rise (in)	= 42.0		
Shape	= Circular	Highlighted	
Span (in)	= 42.0	Qtotal (cfs)	= 207.00
No. Barrels	= 1	Qpipe (cfs)	= 78.88
n-Value	= 0.024	Qovertop (cfs)	= 128.12
Culvert Type	= Circular Corrugate Metal Pipe	Veloc Dn (ft/s)	= 8.68
Culvert Entrance	= Headwall	Veloc Up (ft/s)	= 9.65
Coeff. K,M,c,Y,k	= 0.0078, 2, 0.0379, 0.69, 0.5	HGL Dn (ft)	= 1074.22
		HGL Up (ft)	= 1074.18
Embankment		Hw Elev (ft)	= 1076.34
Top Elevation (ft)	= 1075.36	Hw/D (ft)	= 1.41
Top Width (ft)	= 4.79	Flow Regime	= Inlet Control
Crest Width (ft)	= 43.00	-
