RE: Review of Downstream Conditions  
Drainage District No. 35  
Project No.: 24X.134908.000

CERRO GORDO COUNTY, IOWA  
 DD 35 MAIN TILE & DITCH REPAIR  
 PLAN & PROFILE

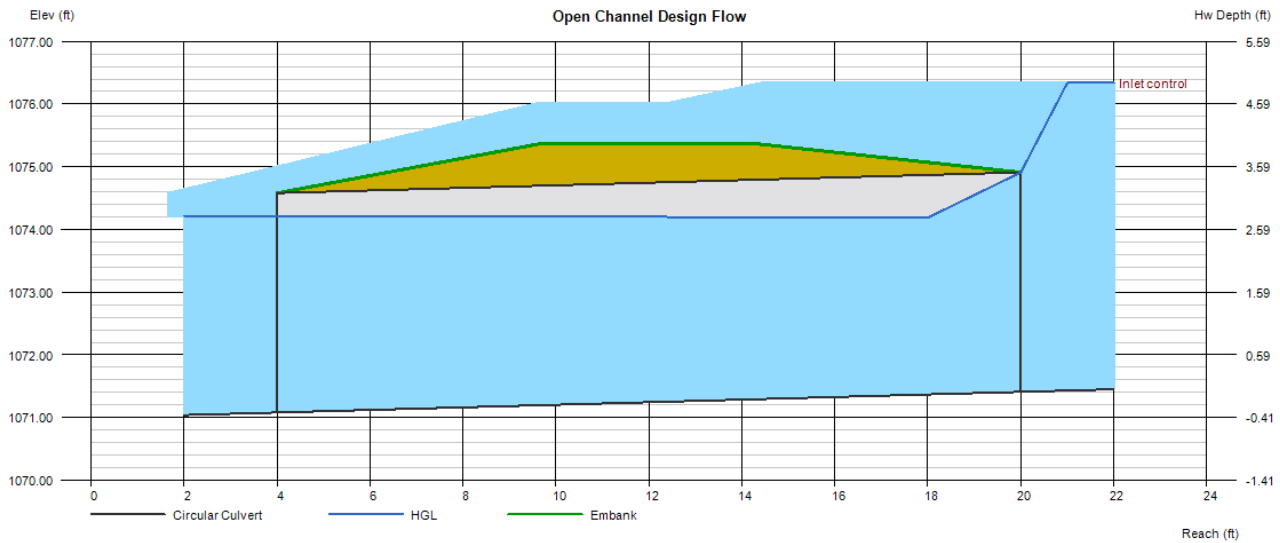
# Culvert Report

From the Iowa Drainage Guide, utilizing the drainage curves for grain crops in Iowa, the open channel design flow quantity for that size of watershed is 207 cubic feet per second of water. This volume of water was modeled against the current culvert conditions. The existing culvert capacity was found to be inadequate based on that evaluation, and it is estimated that from that volume of water the culvert would be overtopped. This means that under any normal design criteria events (2-year, 48-hour storms) or larger storm, the drainage district outlet becomes submerged, which creates a forced outlet. This forced outlet condition increases the internal pressure on the upstream portions of the tile system, namely the

<b>Calculations</b>	
Qmin (cfs)	= 207.00
Qmax (cfs)	= 207.00
Tailwater Elev (ft)	= (dc+D)/2

<b>Highlighted</b>	
Qtotal (cfs)	= 207.00
Qpipe (cfs)	= 78.88
Qovertop (cfs)	= 128.12
Veloc Dn (ft/s)	= 8.68
Veloc Up (ft/s)	= 9.65
HGL Dn (ft)	= 1074.22
HGL Up (ft)	= 1074.18
Hw Elev (ft)	= 1076.34
Hw/D (ft)	= 1.41
Flow Regime	= Inlet Control
